**AIRCRAFT GROUND-FLOTATION INVESTIGATION
PART VII DATA REPORT ON TEST SECTION 6**

**W. BRABSTON and W. HILL, JR.
U. S. ARMY ENGINEER WATERWAYS EXPERIMENT STATION**

**TECHNICAL REPORT AFFDL-TR-66-43, PART VII
AUGUST 1966**

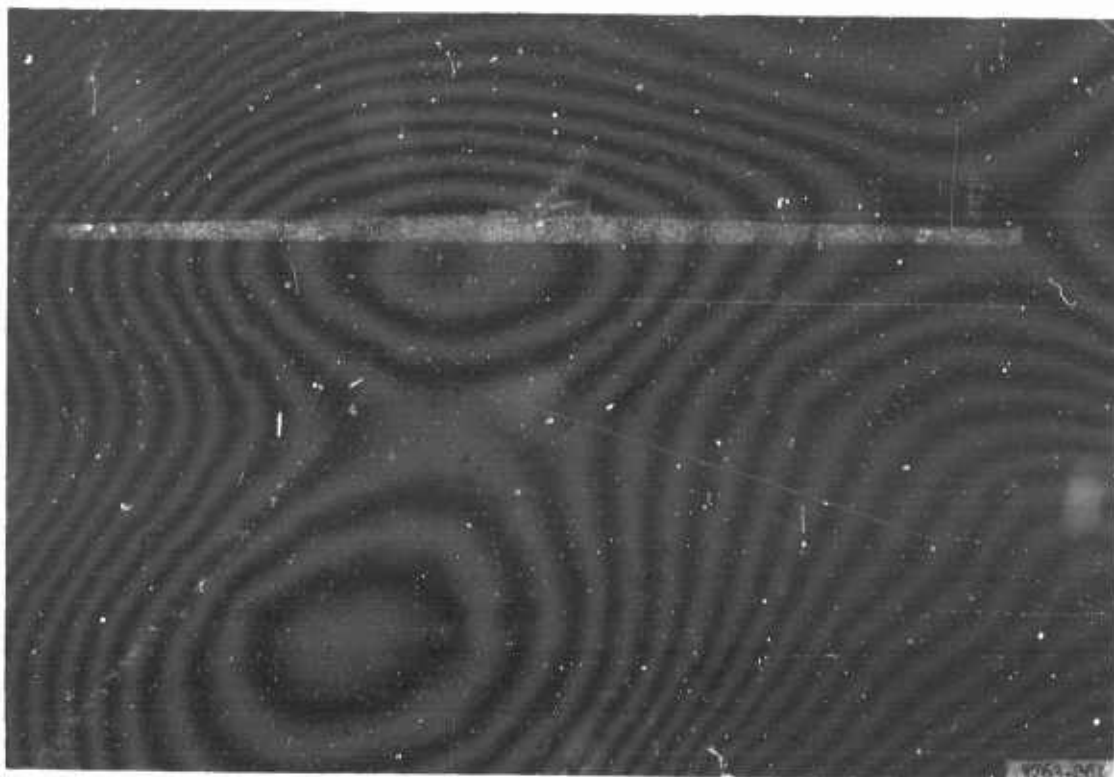
Item 1. Figure 3 shows item 1 prior to traffic. The item sustained 600 traffic coverages without developing appreciable deformations or roughness. No signs of failure were in evidence when traffic was suspended at 600 coverages (figure 4). The rated CBR of the item was 1.5.

Figure 4. Lane 11, item 1. Diagonal straightedge shows slight deformations at 600 coverages

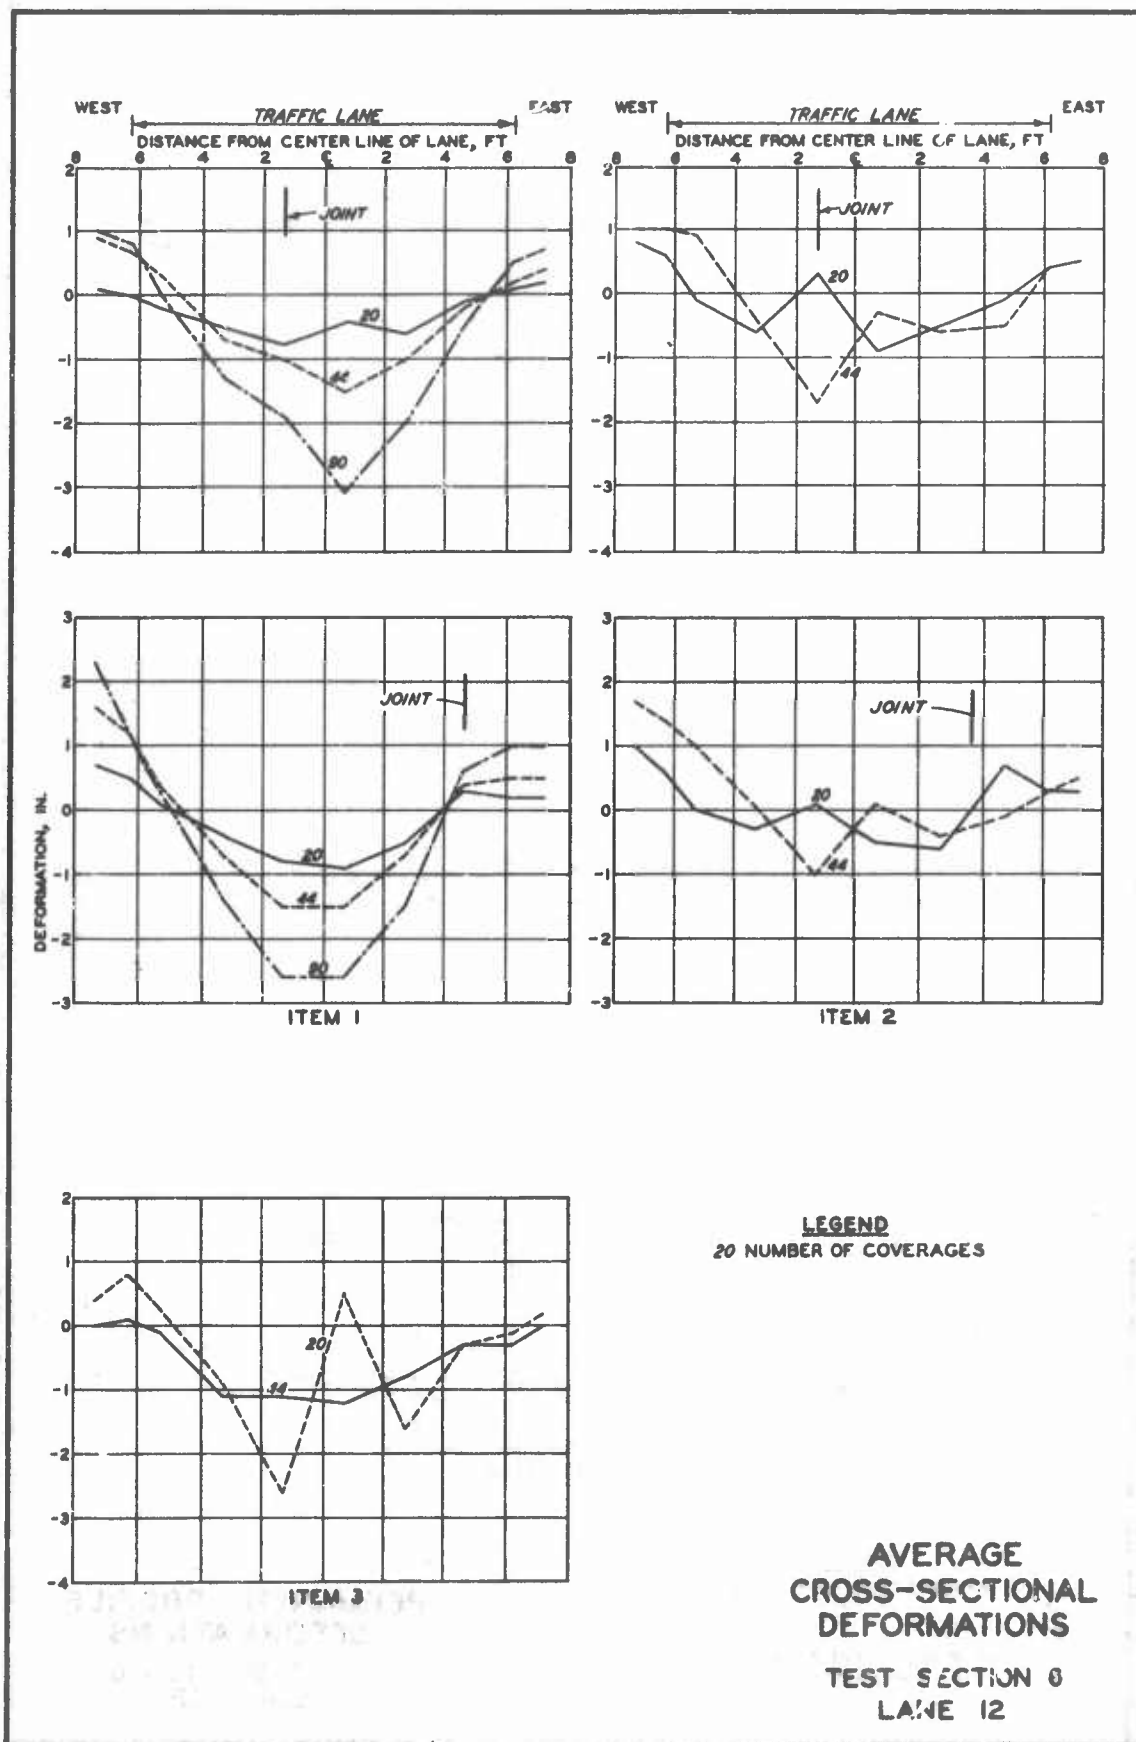
- b. Deformation. Figure 24 shows average cross-section deformations at several coverage levels for two typical mat runs. Center-line profiles are shown in figure 25. Deformations are seen to follow a consistent pattern of increasing severity with trafficking, reaching maximum values at failure of the item.

- b. Deformation. Figure 24 shows average cross-section deformations at 20 and 44 coverages for two typical mat runs. Center-line profiles are shown in figure 25 for the same coverage levels. The downward bend of the panel ends along the mat joint line near the lane center is illustrated in a cross-section plot (figure 24). In previous tests, the panel ends along a mat joint line most commonly protruded upward at failure, as was the case at 20 coverages in this item.

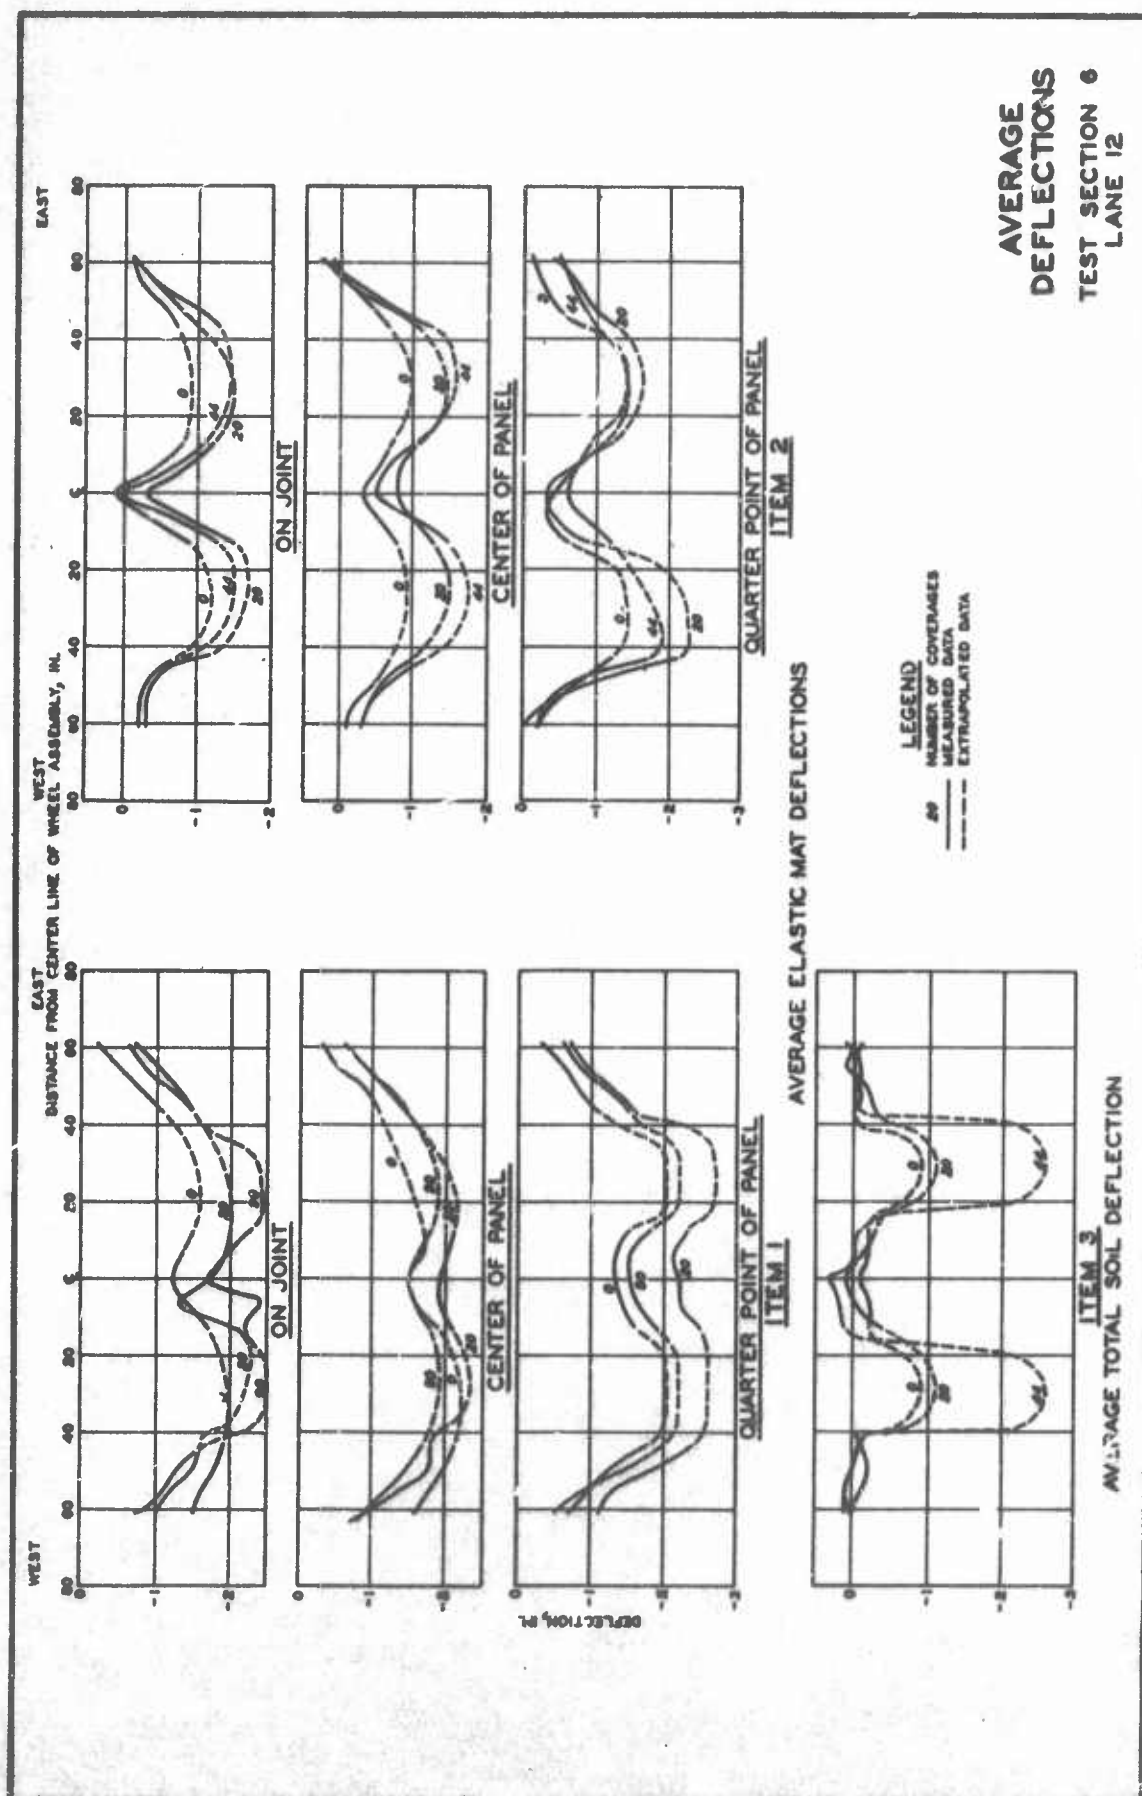
Figure 26

- c. Deflection. Average elastic mat deflections under static load of the load-wheel assembly are shown in figure 26 for three positions of the assembly relative to mat end joints. Deflection measurements were not always consistently greater with higher coverage levels, but decreased in some cases from earlier measurements. Elastic soil deflection at failure measured 2.5 in.

- c. Deflection. Average elastic mat deflections under static load of the load-wheel assembly are shown in figure 26 for three positions of the assembly relative to mat end joints. In some instances, it is seen that the greatest deflections did not always correspond with higher coverage levels. Elastic soil deflections, shown in table 1, measured 1.2 in. at failure.

- c. Deflection. Average total soil deflections are shown in figure 26 for 0, 20, and 44 coverages. A large increase in total deflection is noted at 44 coverages. Elastic soil deflections are shown in table 1. The maximum elastic deflection value recorded was 0.7 in. at failure of the item.
